# NATIONAL TRANSPORTATION SAFETY BOARD

## RAILROAD ACCIDENT REPORT

SIDE COLLISION OF  
TWO MISSOURI PACIFIC RAILROAD COMPANY  
FREIGHT TRAINS  
AT GLAISE JUNCTION,  
NEAR POSSUM GRAPE, ARKANSAS  
OCTOBER 3, 1982

NTSB/RAR-83/06

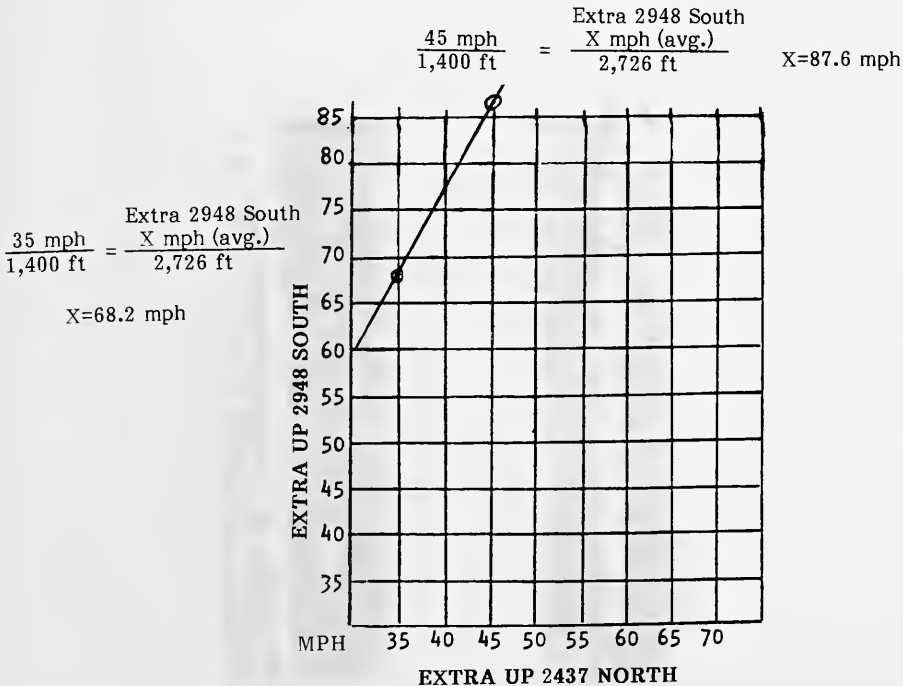
## CALCULATED APPROXIMATE AVERAGE SPEED OF EXTRA UP 2948 SOUTH RELATIVE TO ANY SELECTED SPEED FOR EXTRA UP 2437 NORTH

The engineer of Extra UP 2437 North stated that the locomotives of the opposing trains met at the first road crossing north of Glaise Junction. The distance from the 10-foot clearance point (point-of-impact) for the switch at Glaise Junction to the road crossing was 2,726 feet. The overall length of Extra UP 2437 North was 4,781 feet. At the time the locomotives met at the road crossing, there would have been approximately 2,000 feet of Extra UP 2437 North south of the 10-foot clearance point at Glaise Junction. Because the point of impact at the eighth car ahead of the caboose of Extra UP 2437 North was about 600 feet from the rear of the train, approximately 1,400 feet of Extra UP 2437 North had to move past the 10-foot clearance point after the locomotives met at the crossing. The engineer of Extra UP 2437 North stated that his train was moving at slightly less than 50 mph. In order to allow for latitude in both the speed of Extra UP 2437 North and the proximity of their meeting point at the road crossing, the following graph indicates the relative average speed of Extra UP 2948 South between the road crossing and the point of impact:
